Issued August 2007

Abstract

This technical supplement presents an example of using an aerial assessment and classification of streams in the deep loess region of western Iowa. This is a large-scale effort directed by the Hungry Canyons Alliance involving approximately 5,250 miles of stream in 22 western Iowa counties. This effort has determined areas of active stream erosion and the impact streambed stabilization structures have had on controlling stream degradation. The stream assessment consisted of flying along streams in a small helicopter videotaping the stream channel and recording positions with a global positioning system receiver. Streams were classified based on a six-stage channel evolution model to describe the dominant channel processes occurring along stream reaches. Streams across the region in 1993 and 1994, and in a smaller area in 2000, were similarly classified.

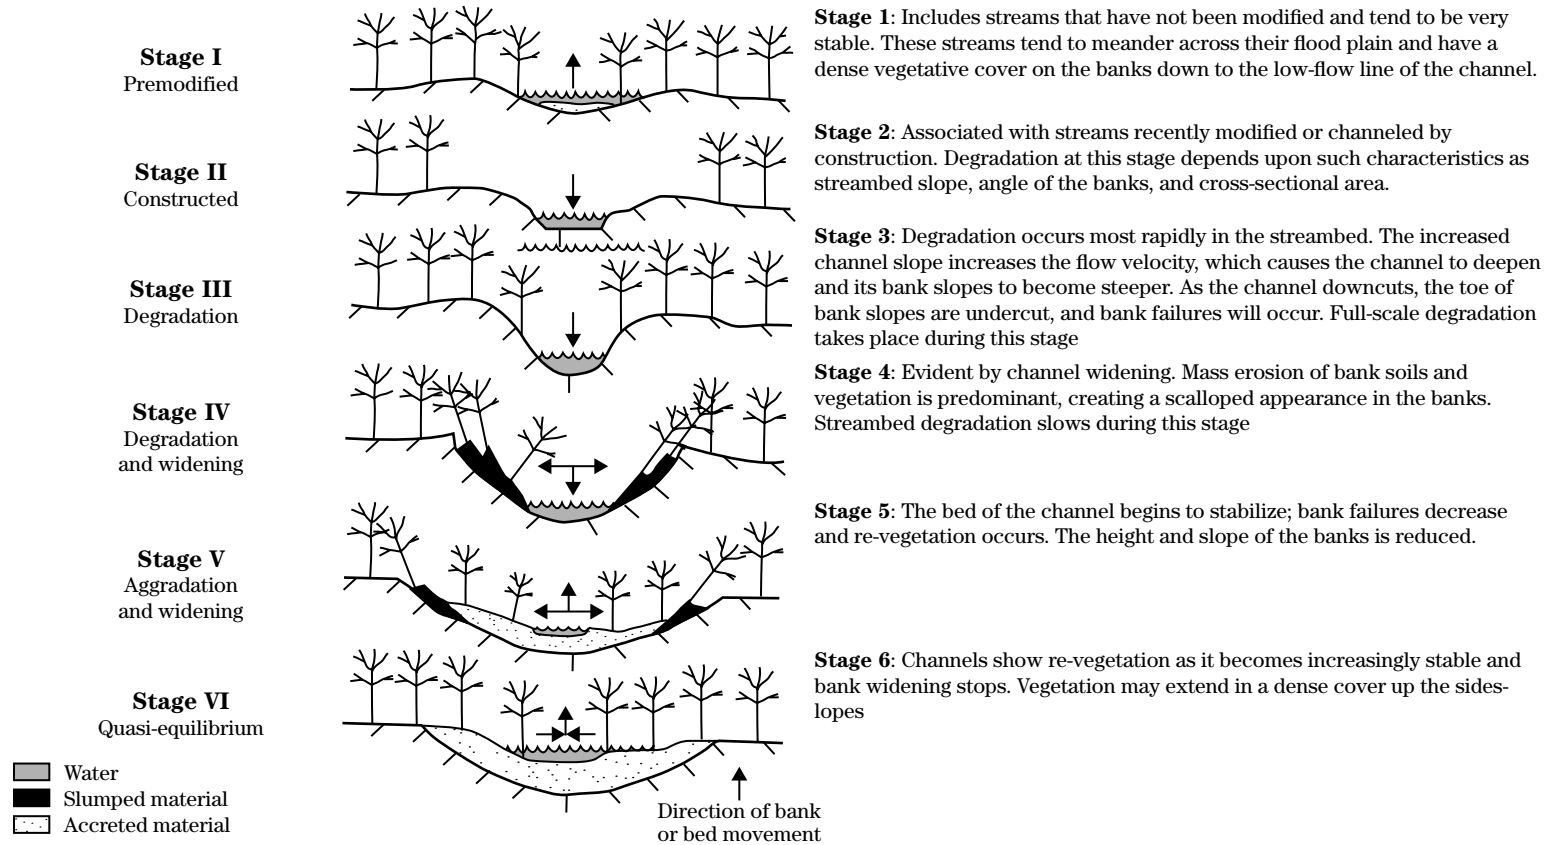
Figure TS3B-6 Six-stage channel evolution model

A six-stage channel evolution model (fig. TS3B-6, developed by Simon and Hupp (1986), was used to describe the dominant channel processes occurring along stream reaches.

In conjunction with a set of manually transcribed notes, the videotape and narration was used to classify streams by Simon's six-stage channel evolution model. Classified stream reach locations were transferred to USGS 1:100,000 scale topographic base maps by hand. These hard copy maps were then converted to a digital data set using the Geographic Resources Analysis Support System (GRASS) geographic information system (GIS) software package. GRASS GIS is an open source free software GIS that is largely command line driven. In 2000, the NRCS reclassified streams in four counties and classified streams in two additional counties using the same process.
