**A Study of Operating Efficiencies Comparing Aluminum Pipe Systems  
to Certa-Set PVC Irrigation Piping**

**Edward Norum, P.E.  
Agricultural Engineer  
The Center for Irrigation Technology  
California State University, Fresno  
Fresno, California April, 2003**

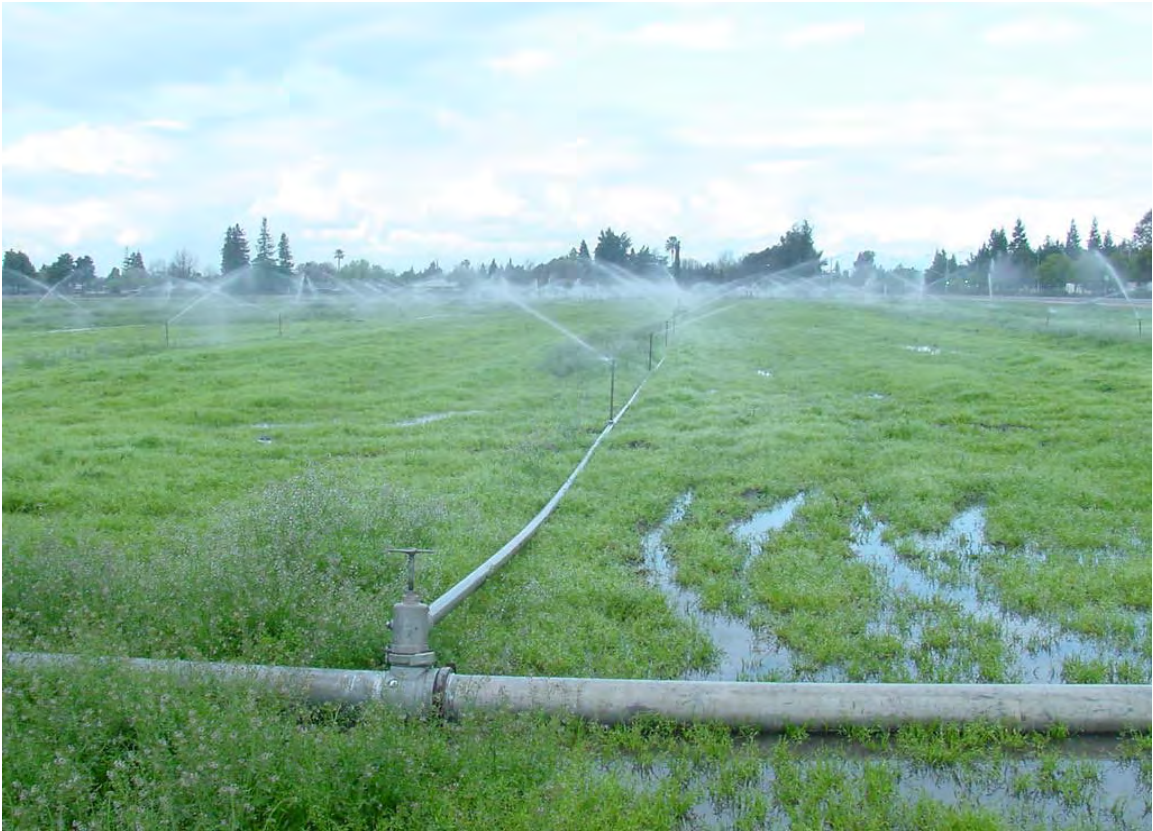
**Figure 1** Portable aluminum pipe solid set system in operation.

Shown in Table #1 are the results from six test runs with an aluminum pipe system. The system consisted of 1200 ft. of 8 in. mainline with five 3 in. by 1140 ft. laterals attached at the distal end. The sprinklers were spaced 30 ft. X 50 ft. The runs simulate irrigation events with gross applications ranging from 1.2 to 1.7 inches. The net volume shown in Table #1 is calculated knowing the pressure at the end of the laterals, the number of sprinklers operating, and the net runtime when the sprinklers have reached the correct operating pressure. The gross volume is determined from the 8-in. mainline flow meter and the net runtime. The operating efficiency is the ratio of net to gross volume. The resulting average operating efficiency is 86.3%. These results show the losses to be 13.7% from the combined effects of leakage when the system is operating, drainage when it is shut down and variations in sprinkler operating pressure.

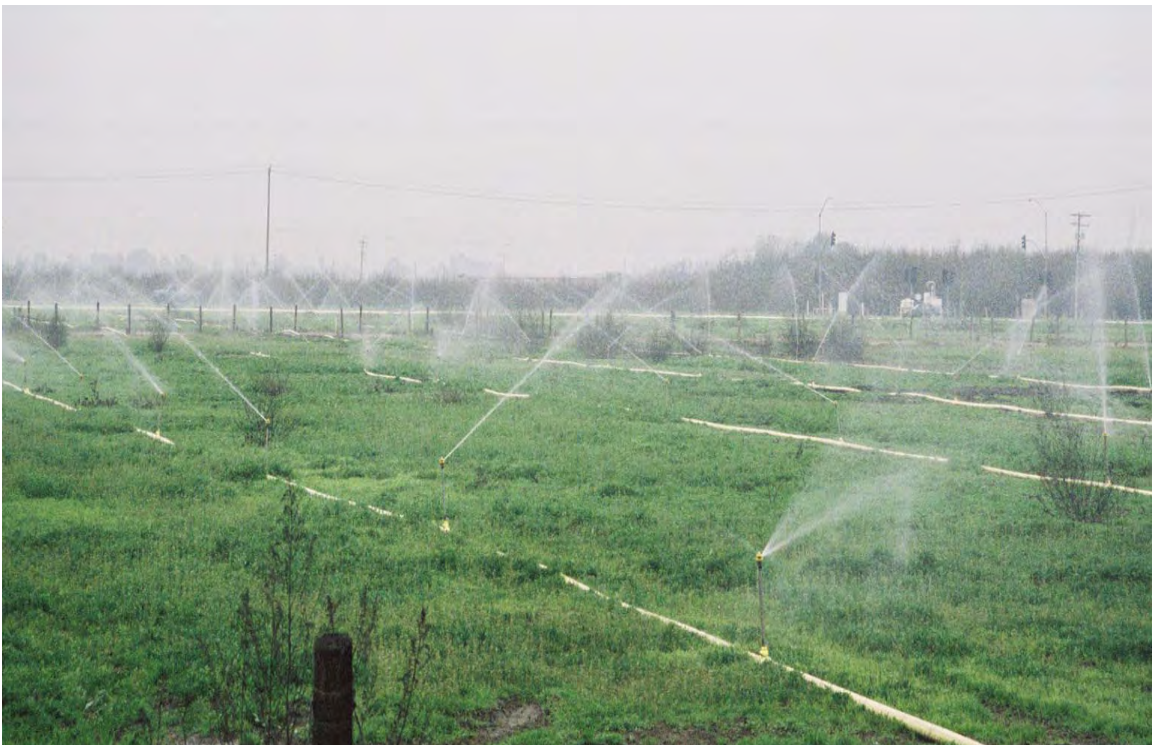
**Figure 2** Certa-Set PVC irrigation piping portable solid set system in operation.

Shown in Table #2 are the results from six test runs with the Certa-Set irrigation pipe system. In this case the runs simulate irrigation events with gross applications ranging from 0.4 to 1.7 inches. The PVC pipe system was laid out in a manner identical to the aluminum pipe system except the sprinkler pipe spacing was 40 ft. X 40 ft. In this case, the average operating efficiency was 94.8% which shows the losses to be 5.2%. After the initial filling of the system, it stayed full between runs even during a weekend shut down. This suggests that the water loss is limited to the variations in sprinkler operating pressure. It follows then that this value could be minimized by reducing the headloss in the laterals or the use of pressure-compensated sprinkler components.

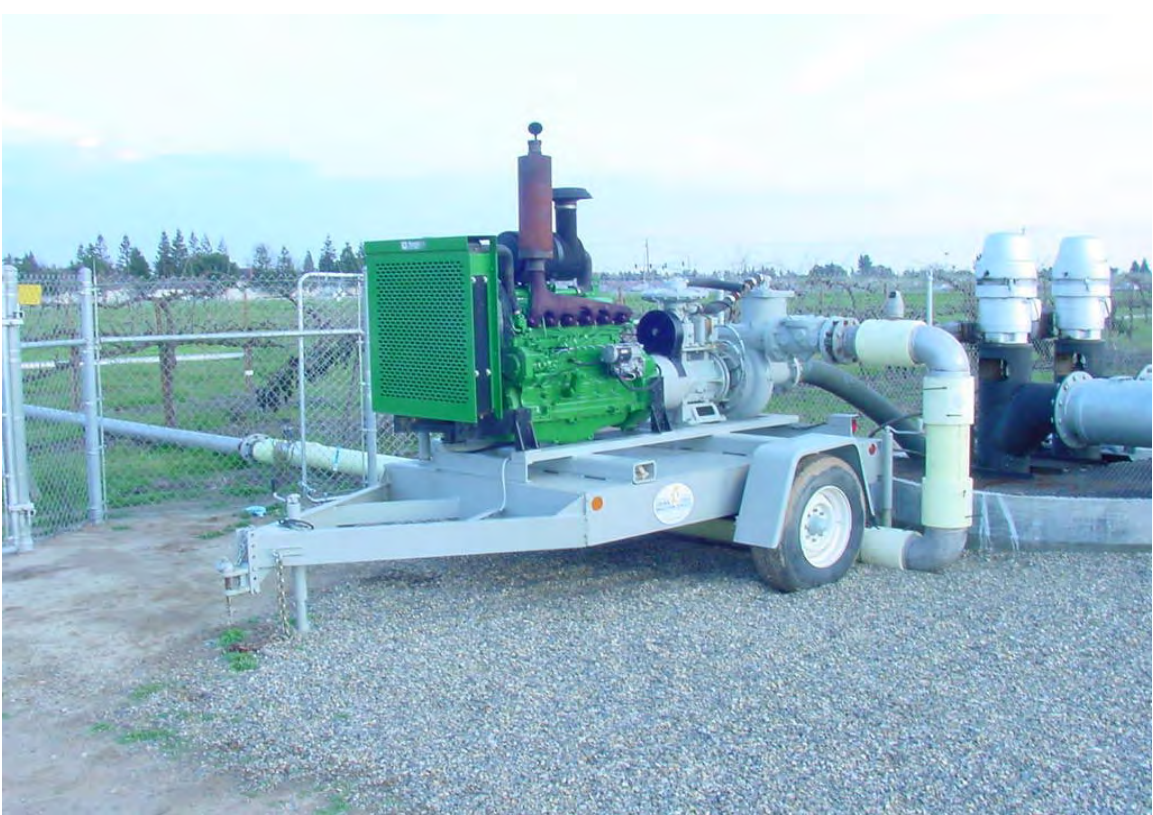
**Figure 3** Portable pumping plant. Note the water meter is visible in the 8 inch mainline just outside of the security fence.

The site was on the California State University, Fresno Farm Laboratory, field 13 with a gross area of approximately 25 acres. The mainline and lateral layout was meant to be typical of commercial systems. The area was not cropped. Observations on the flooded condition of the PVC plastic pipe system suggested that the field topography was generally flat. Figure #1 and Figure #2 show the aluminum pipe and the PVC piping systems in operation, respectively. Water was supplied to the system using a portable diesel-powered pump as shown in Figure #3. The pump drew water from a standpipe on the edge of a large reservoir. The flow meter is a McCrometer 8 in. saddle meter model M0300. The flow meter calibration was checked against the master meter in the CIT laboratory.

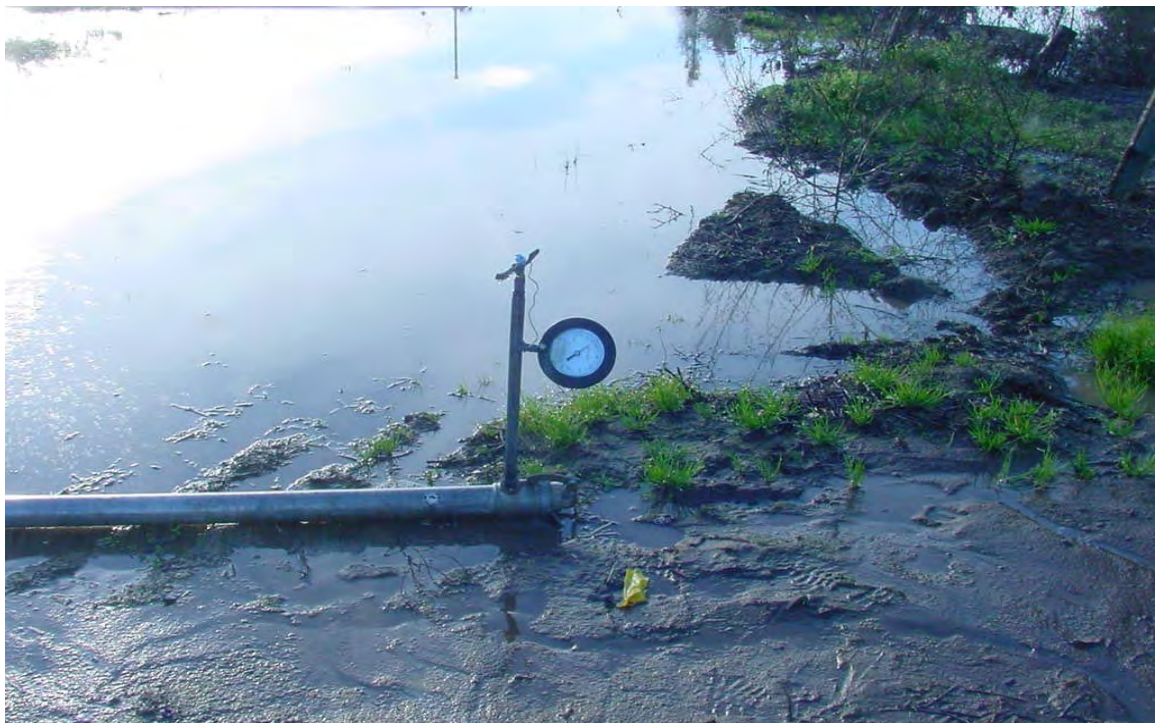
**Figure 4** Pressure gauge mounted on a riser at the end of the lateral.

The system operating pressure was measured on a riser at the high end of the lateral as shown in Figure #4. The pressure tap was designed to recommend good practice standards. The same tap was used for the sprinkler calibration tests. The gauge is an Ascroft test gauge with a 4½" face and a Grade 3A with an accuracy of ¼" of full scale. It was checked before and after test sequences and found to agree with a dead weight tester to within ¼ psi. During the test run the pressure was recorded and a Dickson Model PW4 Recorder. These chart records were confirmed by periodic reading of the pressure gauge and stop watch manual records of run times.

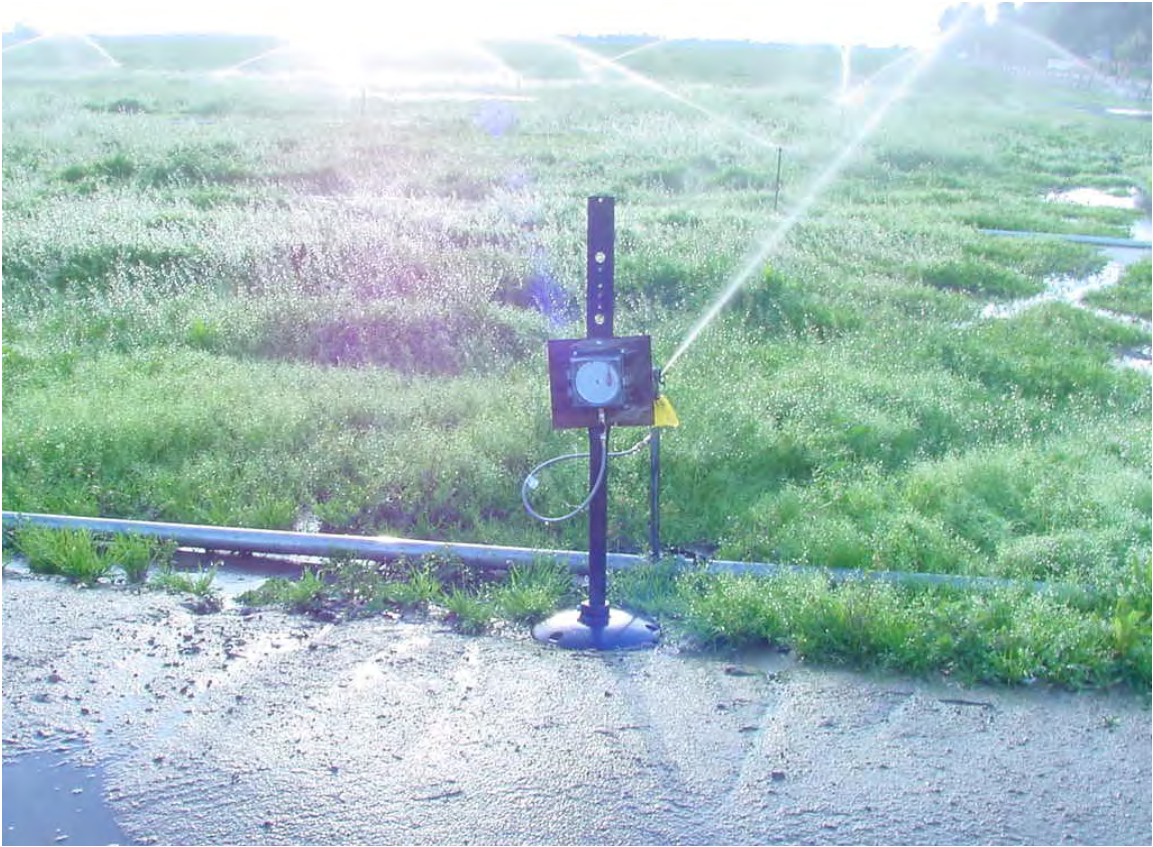
**Figure 5** Recording pressure gauge located on the second from the end sprinkler.
