## Use of Gravity Drip on the Navajo Nation

### ABSTRACT

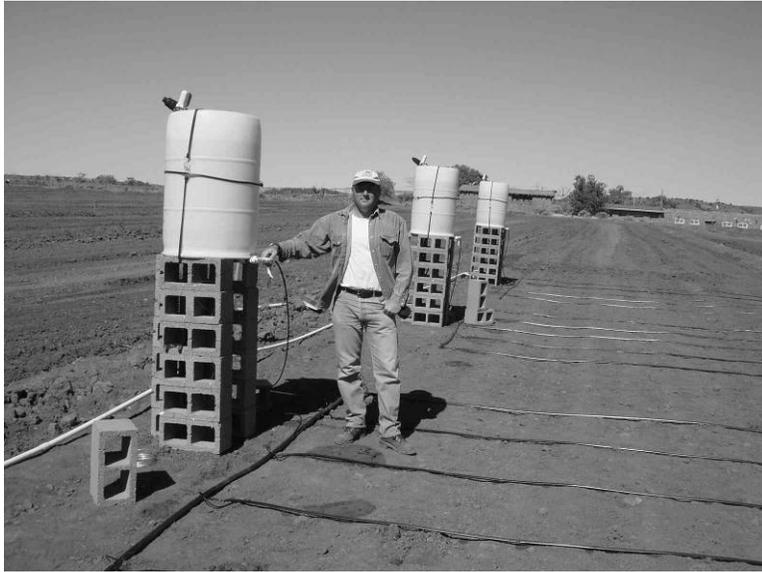
Figure 5: View of the drums as installed at the Hubbell Trading Post research site.

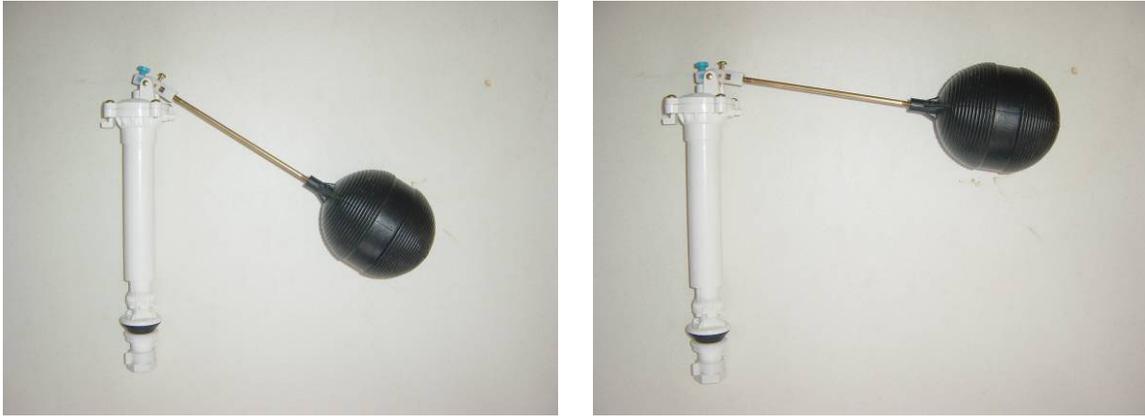
Figure 7: Overflow prevention valve operation: left picture shows float up (off) position, right picture shows float down (on) position.

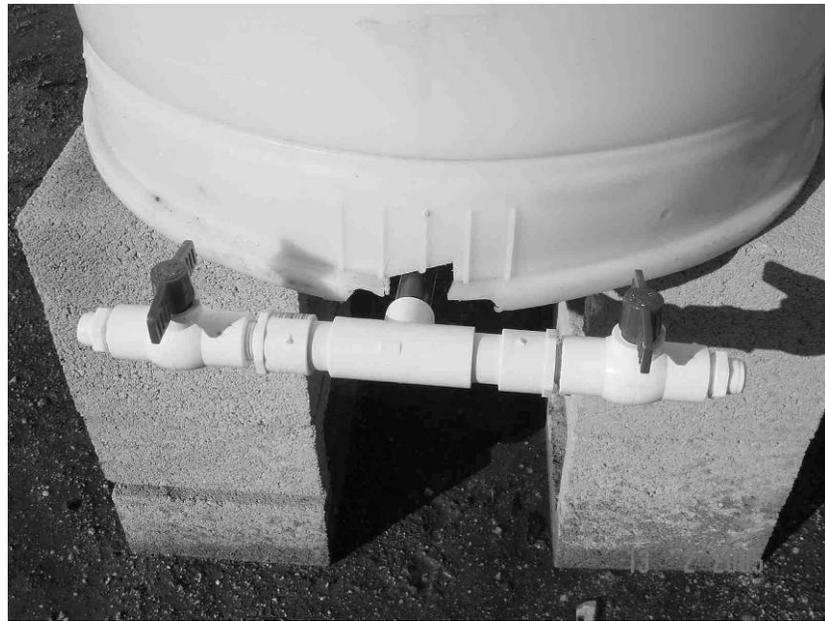
Figure 8: Base of the irrigation drum showing PVC outlet valves and connections.

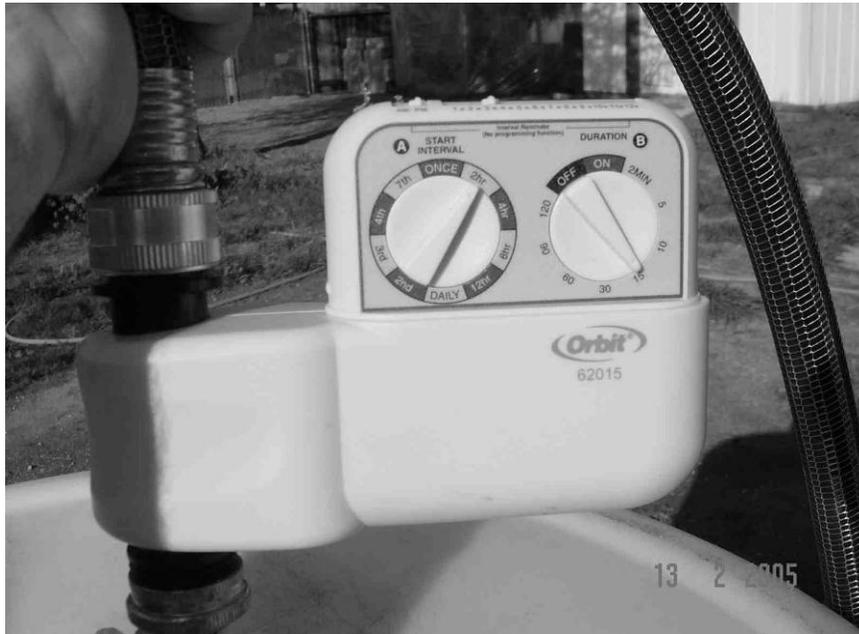
Figure 9: Spigot Mounted Inline Irrigation Water Controller, model 62015 by Orbit.

A battery operated irrigation controller, inline spigot mounted type 62015 from Orbit, was used to control irrigation water applications (Fig. 9). The controls could be set to allow watering intervals of 2, 5, 10, 15, 30, 60, 90 and 120 minutes at set intervals between irrigation events of 2, 4, 8, or 12 hours, or daily, every second, third or fourth

day, or once weekly. Initial tests showed that a drum would fill in less than 15 minutes at typical city water supply pressure and in approximately 25 minutes at pressure on the irrigation pipeline at the Hubbell Trading post. Being limited to the set times on the device a fill interval of 30 minutes was used (greater than the fill time of the drum), and the float valve was used to prevent overflow. At the end of the 30-minute interval the timer closed the main valve mechanically. As the outlet valves to the drip tubing were typically left in the open position, irrigation would begin as soon as the drum started to fill and the plots typically received more than a full drum of water on each irrigation event, being fed from the start of filling until the drums emptied.

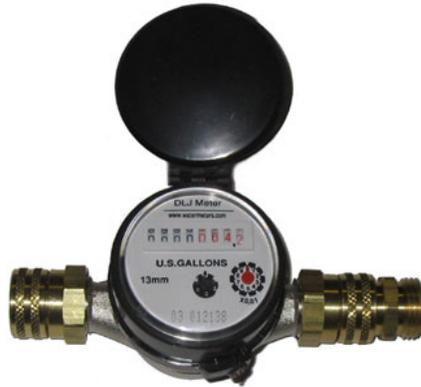
Figure 10: DLJ Hose Bibb (Sill Cock) Water Meter with 13 mm Garden Hose Thread inlet and Outlet.

In order to measure daily water use and cumulative water use for the season DLJ Hose Bibb Water Meters were installed on each system (Fig. 10). The water meters are accurate to standards specified by the American Water Works Association (AWWA). The water meters contain course mesh filters to exclude large debris from the unit and had to be checked at intervals. Standard 13 mm threaded male and female connections on the water meters allowed easy connection to hose fittings and automatic irrigation timers.

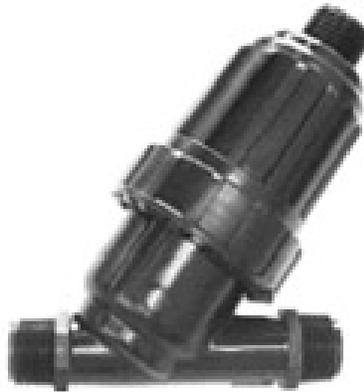
Figure 11: Thirteen mm MIPT 'Y' Irrigation Filter with threaded Cap.

In 2005 small inline canister type filter units with removable screen filter tubes were used on each system (Fig. 11). In 2006 a much larger screen filter unit was used in the supply line upstream of all three systems at the Hubbell Trading Post (Fig. 12). This was done to reduce filter cleaning to one filter instead of three and provide a larger filter mesh area.

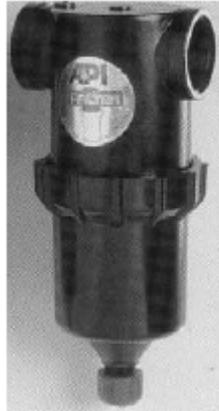
Figure 12: Aquarius Brands Incorporated 5.1 cm T-type screen filter with bottom outlet for quick flushing.

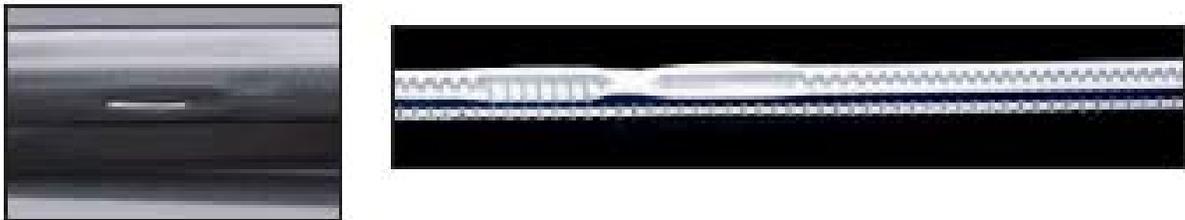
Figure 13: Section of Chapin Drip tape showing a slit emitter and the zig-zag pattern of filter within the twin-walled drip tape. Source: Chapin Watermatics Inc., 2007.

The Chapin drip tape used is sold as a kit specifically for use on small plots and is part of the Super Bucket Kit (Chapin Living Water Foundation, 2007). The drip tape is constructed from durable 15 mil plastic and is sold as a 90-meter roll of flat tape with precision laser-cut emitter slits every 30 cm. Inside the twin walled drip tape is a strip containing 10,000 filters per 30-meter length, which keeps water flowing in a turbulent flow regime and provides a self-cleaning function. The zig-zag pattern of this filter mechanism also helps to maintain a uniform pressure throughout the drip tape length (Fig. 13).

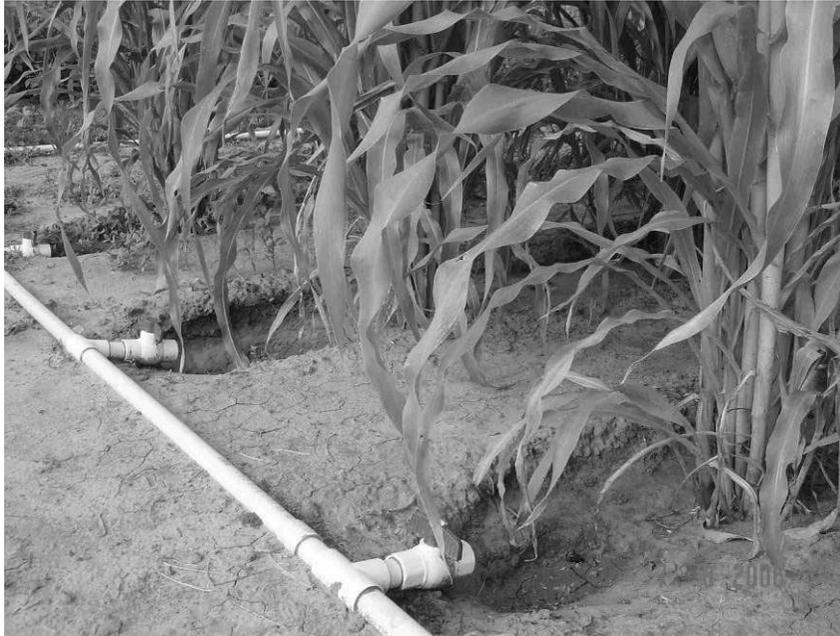
Figure 16: Individual control valves at the head of each furrow, Hubbell surface plot, 2006.

Unfortunately, problems with flow measurements made it difficult to determine accurately the amount of water applied to the surface plots. In 2006, the surface irrigation system for the surface plot was replaced with a furrow planting configuration with individual control valves at the head of each furrow as shown in Figure 16.
