Technical Supplement 14A

Soil Properties and Special Geotechnical Problems Related to Stream Stabilization Projects

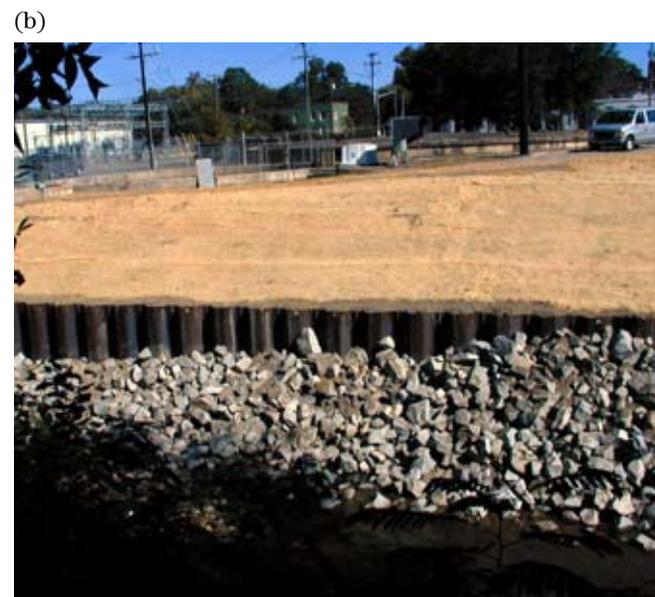
Figure TS14A-11 Sheet pile wall at toe of slope in Tarboro, NC. Vegetation will be established above wall. Note erosion control fabric.

Figure TS14A-11 shows a project where the toe of the slope was protected using both riprap and a sheet pile wall. In many circumstances, rigid boundary constraints, improvements, or other obstacles at the top of the slope do not allow the slope to be flattened. Consequently, constructing a vertical feature at the toe of the slope may be needed.

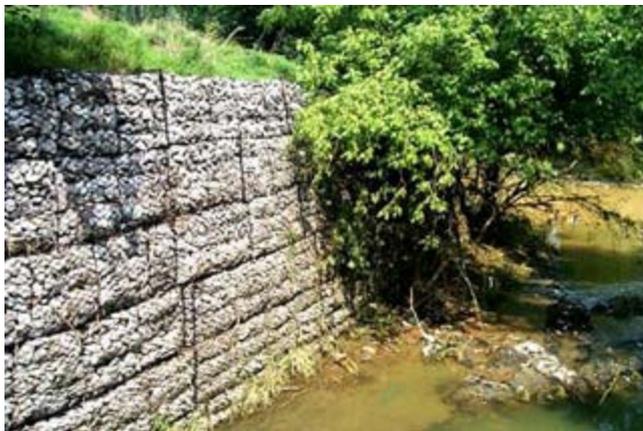
Figure TS14A-12 Gabion wall constructed at toe of slope enabled reconstruction of failed slope where right-of-way limitations prevented flattening of the upper slope and use of other conventional toe protection measures at the toe

Another way of reconstructing a slope where limited right of way occurs is the use of gabion baskets to protect the toe of the slope (fig. TS14A-12).

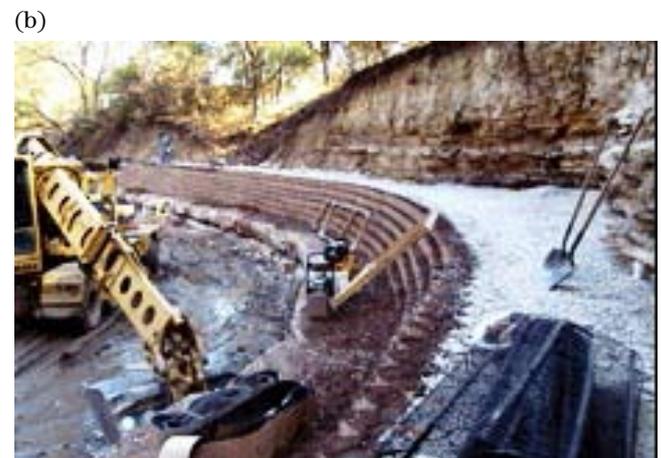
Figure TS14A–13 Reinforced fill at toe of slope in Austin, TX. Note large stones used to protect reinforced fill from erosive forces in stream.

angle than would otherwise be possible. Examples of geosynthetic reinforcement include the use of geogrids and geocell products. These products are described in NEH654 TS14D. Figure TS14A–13 illustrates a project where the toe of the slope was protected by armoring, and the slope was reconstructed with reinforced soil lifts.

Figure TS14A–13 shows the reconstruction of the slope at the West Bouldin Creek at South 6th Street project. Figure TS14A–13(a) shows the site in the initial stages of construction. The toe of the slope has been excavated in preparation for installing limestone boulder armor

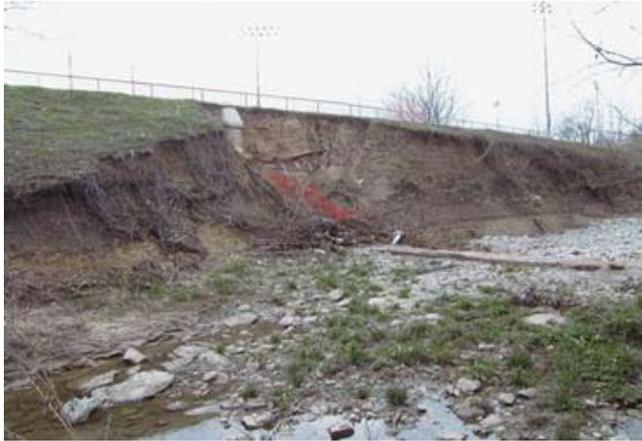
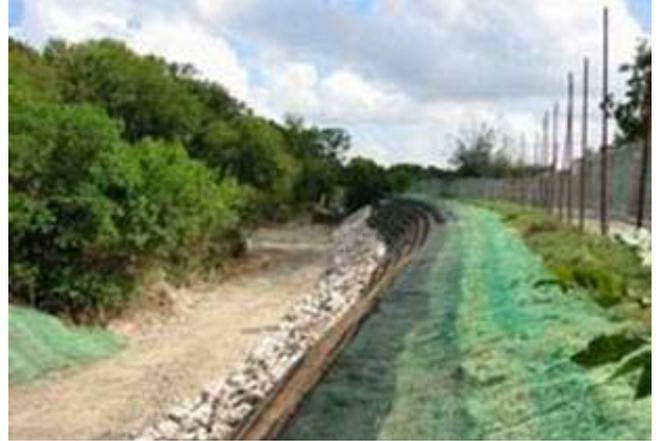
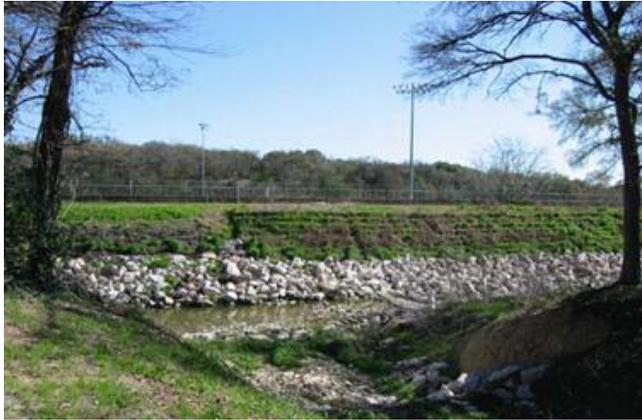
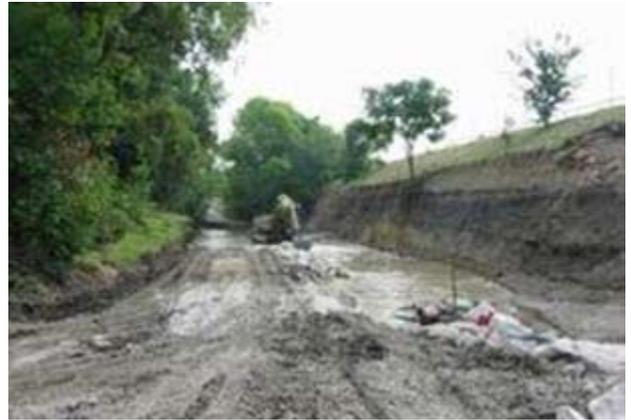
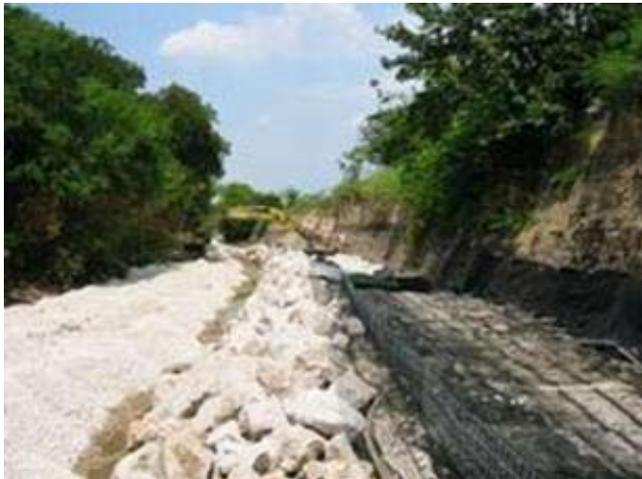
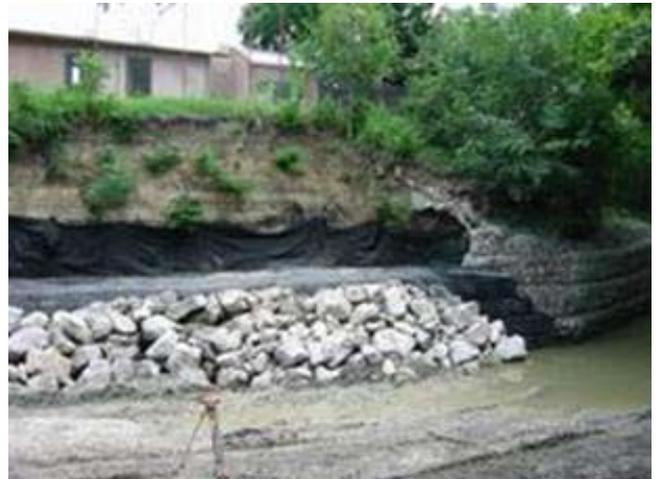
Figure TS14A-15 Other slope stabilization projects

Figure TS14A–15 shows other slope stabilization projects where reinforced fill protected by rock armor riprap placed at the toe of the slope were employed. Figure TS14A–15(e) shows geogrids, a heavy lattice of very strong plastic placed in layers in the granular fill used to reconstruct the slope. Figure TS14A–15(f) shows the completed project.

allows vegetation to grow and mask the construction. Geocells allow very steep slopes to be used in the reconstruction. These six photographs show a project to stabilize unstable streambanks at the Shoal Creek Project, City of Austin, Texas (fig. TS14A–15).

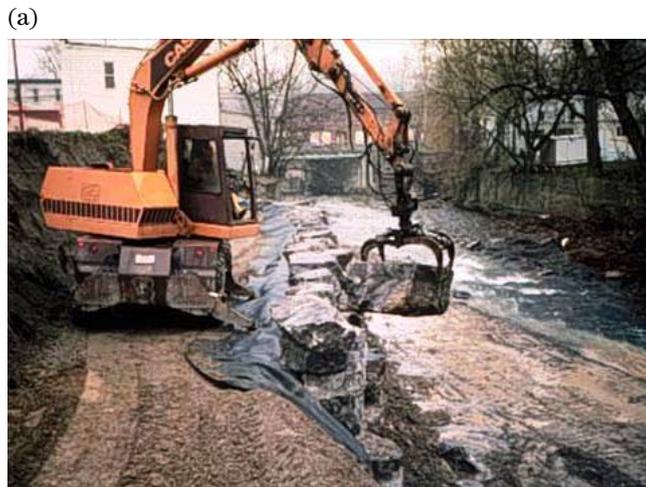
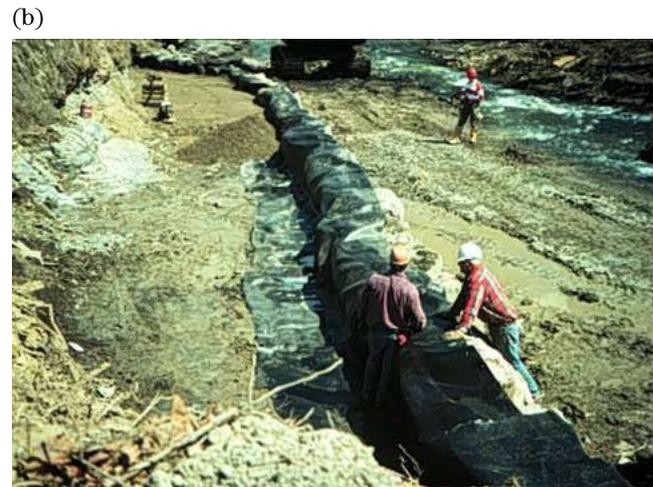
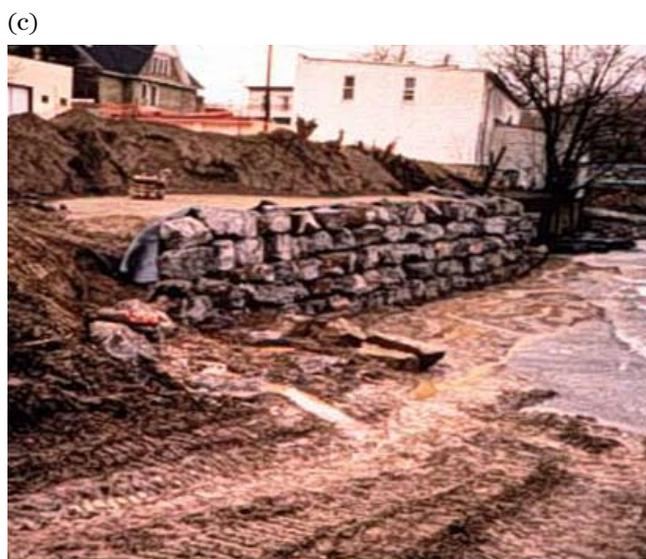
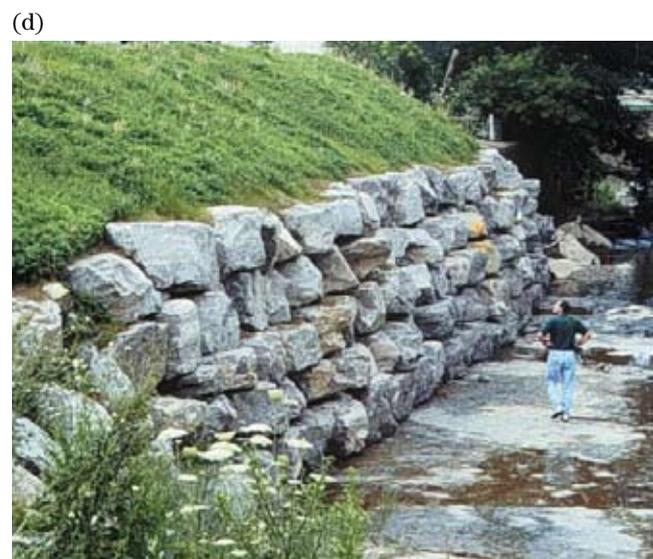
Figure TS14A-16 Construction of a geotextile reinforced slope with large derrick stone armoring at toe of slope

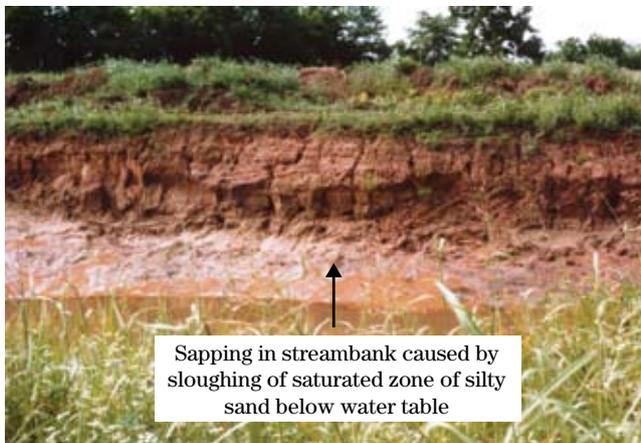
Figure TS14A–17 Sloughing of saturated low plasticity zone in lower streambanks caused by seepage forces

be able to form a roof. In a related mode of failure, the saturated bank in this zone of low plasticity soils slumps or sloughs under the seepage forces. Sloughing of the lower banks can undermine overlying zones that are stable on a steeper slope. Figure TS14A–17 shows sloughing in the lower saturated banks of an excavated stream.

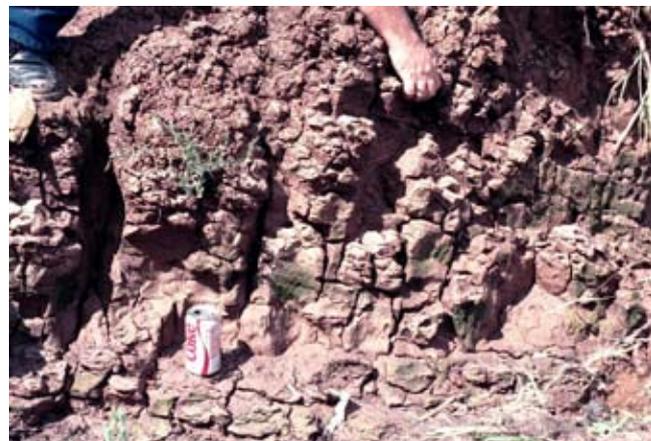
Figure TS14A–19 Slickensides in exposure of clay soil

Figure TS14A–19 shows photographs of highly plastic clays with slickensides and blocky structure. Shallow surface slides commonly occur in these soils where streams have been modified or the stream system is not in equilibrium and bed degradation is occurring.

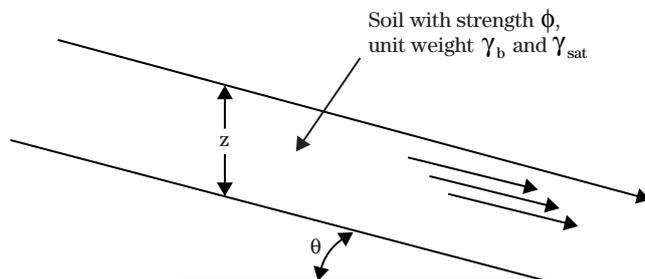
$$FS = \frac{\bar{c} \times \gamma_b \times z \times \cos^2 \theta \times \tan \bar{\phi}}{\gamma_{sat} \times H \times \sin \theta \cos \theta} \quad (\text{eq. TS14A-1})$$

Figure TS14A-22 Infinite slope equation for slope with small cohesion value

In silty, clayey, coarse-grained soils, a significant cohesion property may be present in effective stress parameters. For this assumption, computerized slope stability analyses can be used to calculate factors of safety by various methods such as the method of slices. These types of computer analyses are not appropriate for zero-cohesion soils because the critical failure surfaces are very shallow on the slope face with factors of safety approaching those obtained using the infinite slope equations.

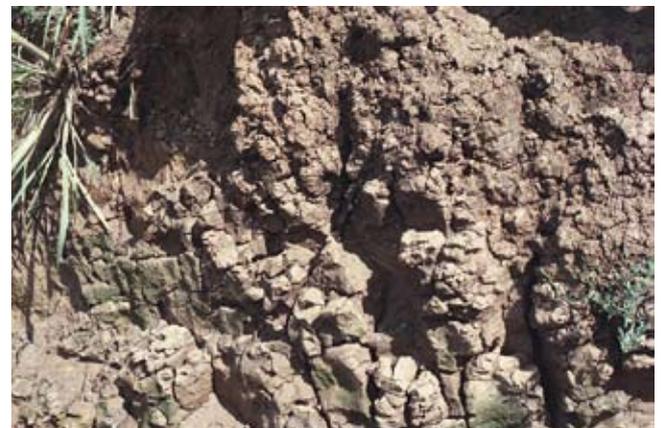
Figure TS14A-23 Blocky structured clay in streambank exposure

The soils have an observable strongly blocky structure in an exposed face. The blocks of clay may be from one quarter to three-quarter inch in dimension. Figure TS14A-23 shows an exposure in a blocky clay soil. Other photographs show slickensides that are present in many such deposits. Slickensides develop from repeated wetting and drying cycles in clays.

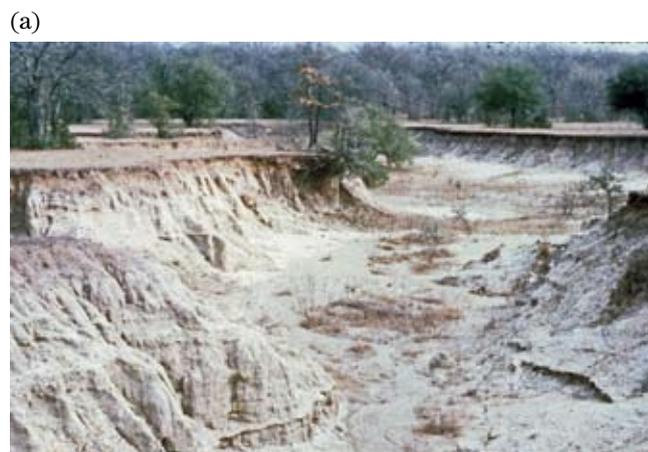
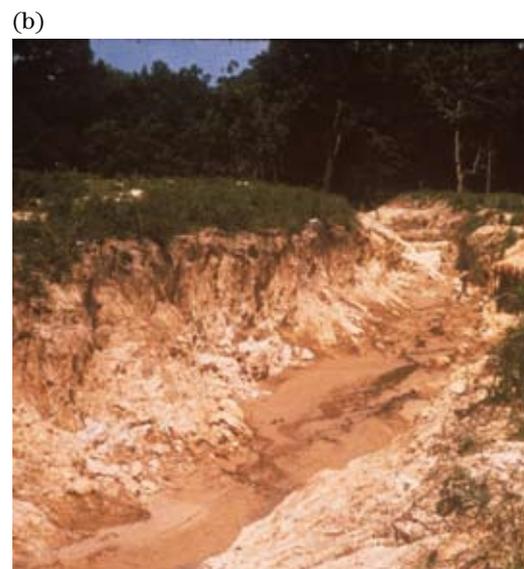
Figure TS14A–24 Photographs of exposure of dispersive clays in streamside slopes in TX and OK

Dispersive clay slopes often are severely rilled. These rills often develop in a short time. Jugholes are an ideal diagnostic tool for dispersive clays. These features develop when a drying crack in the exposed soil provides an entrance for precipitation that can then erode the sides of the wall. This internal erosion of the crack results in subterranean cavities often termed jugholes. Figure TS14A–24 illustrates the special appearance of dispersive clays.

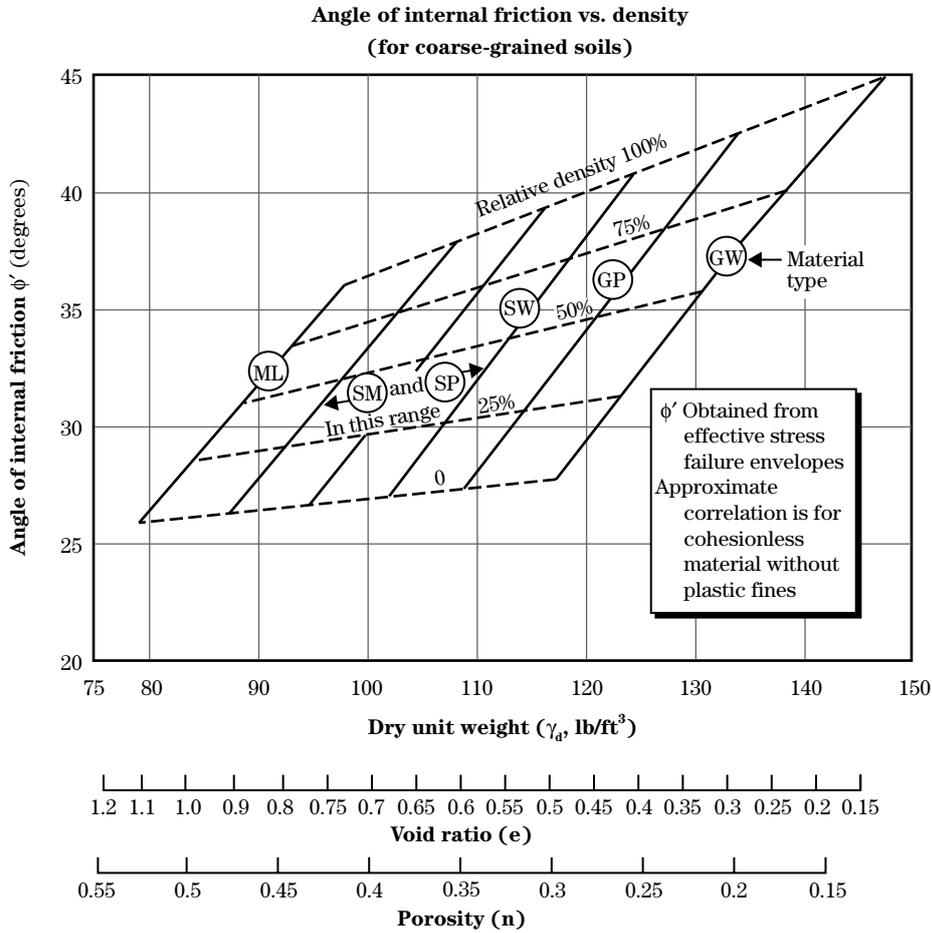
Figure TS14A-27 An example of a chart used to estimate effective friction angles for different types of soils
